CASTRUM LUBENOV.

CALAMITY OF THE TOWER CASTLE IN LUBRZA

Abstract: Due to illegal construction works in 2016, the late medieval motte-and-bailey castle in Lubrza was significantly damaged. The immediately undertaken rescue excavations paradoxically led to better understanding of the complex based on the obtained archaeological evidence as well as written sources, architectural studies, and remote sensing data. Detailed analysis of the artefacts has made it possible to establish the basic occupations of the inhabitants of the tower, their standard of living, everyday life, wealth, diet, and social status. The archaeological research also allowed us to establish accurate chronology of the complex, which should be placed in the 14th century.

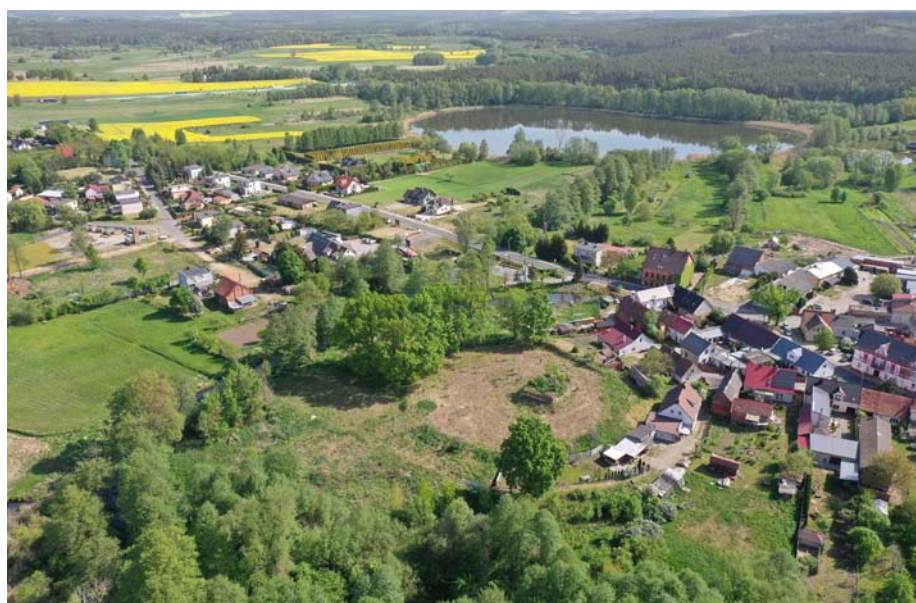
Fig. 2. View of the relics of the site in Lubrza from the south-west, 2022. Photo: H. Augustyniak.

Unfortunately, however, a catastrophe occurred in 2016: due to illegal construction activities, most of the mound and other adjacent landscape remnants were levelled and the original terrain form was lost. The material from the motte was used to level the surrounding area. Although a part of the stone tower's ground floor has survived *in situ* (Fig. 5), the historic substance of this important site was irretrievably destroyed. Recent analysis of the legal situation of the late medieval stronghold in Lubrza before its destruction in 2016 provides clear evidence that the current owner of the property had full knowledge of its status as a protected cultural heritage site and carried out

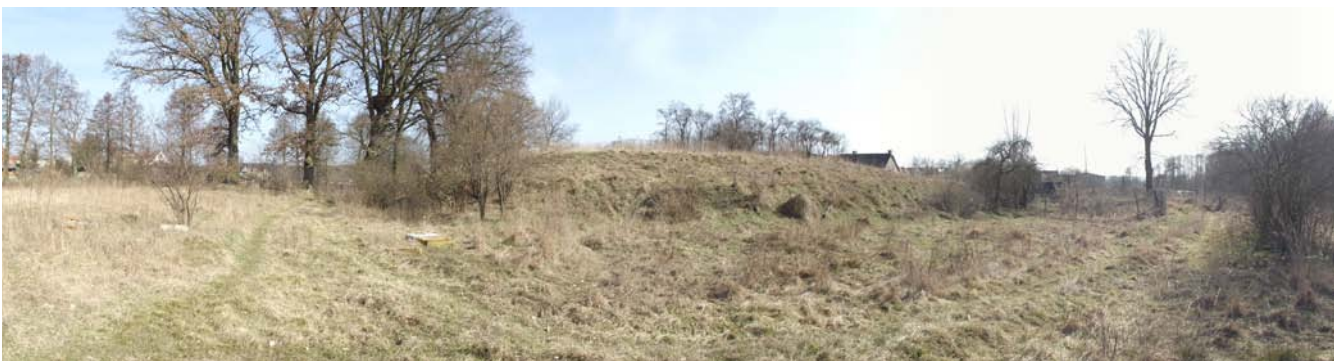
Fig. 4. North-west view of the site before destruction. Photo: R. Jurga.

20th century (Fig. 3).³ One can also find brief mentions of the tower castle in papers published after the Second World War (Fig. 4).⁴ Based on the written sources from the Middle Ages, the stronghold in Lubrza functioned between the 13th and 15th centuries.⁵

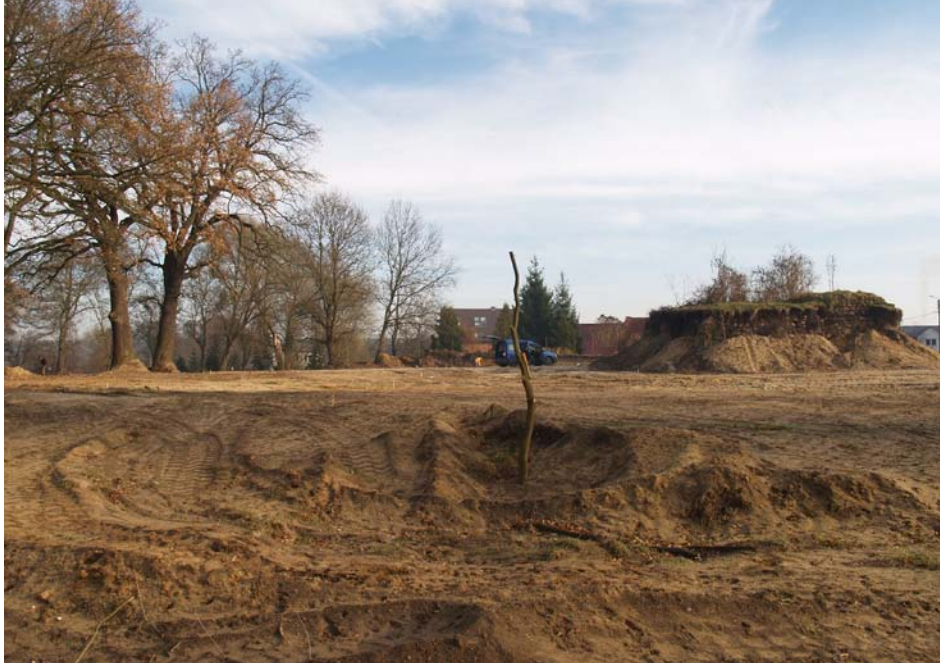
Fig. 5. North and central part of the site after the destruction of the mound. West view. Photo: S. Kalagate.

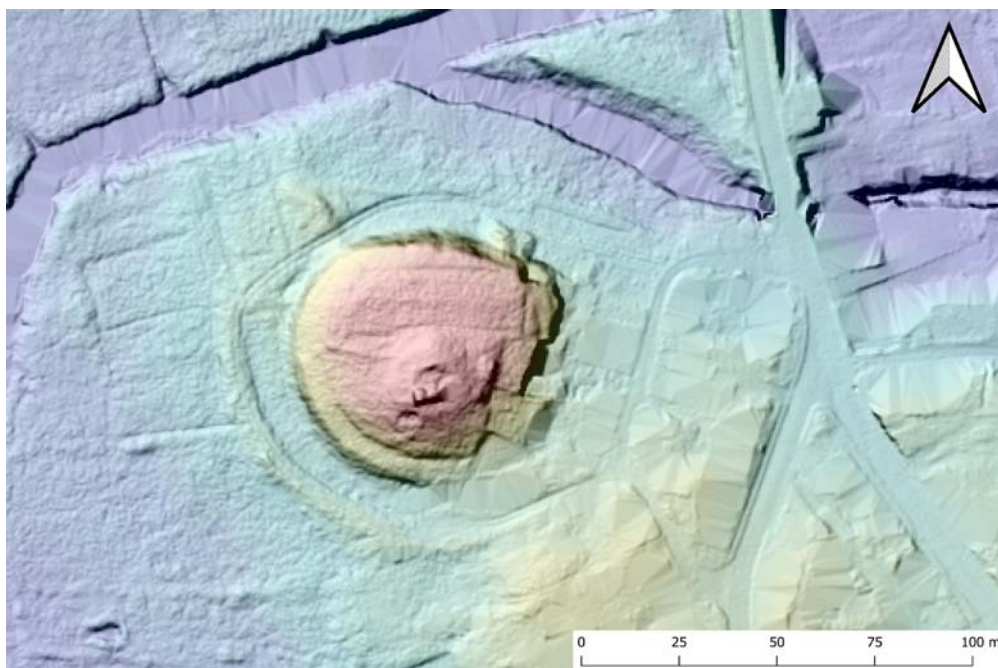
Fig. 7. Derivatives of numerical terrain models from airborne laser scanning showing the Lubrza stronghold before destruction: composition of shading analysis and numerical terrain model. Graphic design: G. Kiarszys.

3-5 meters high, with a diameter at the base of approximately 30-60 meters, and at the top of approximately 10-20 meters (Fig. 6). The building was surrounded by a moat, which was probably formed during the excavation of the earth used to build the motte. The whole complex could have been surrounded by a defensive wall. At the top of the motte was a residential stone tower, hypothetically surrounded by a palisade. There was most likely also a suburbium, a kind of settlement situated near the castle (Fig. 7).

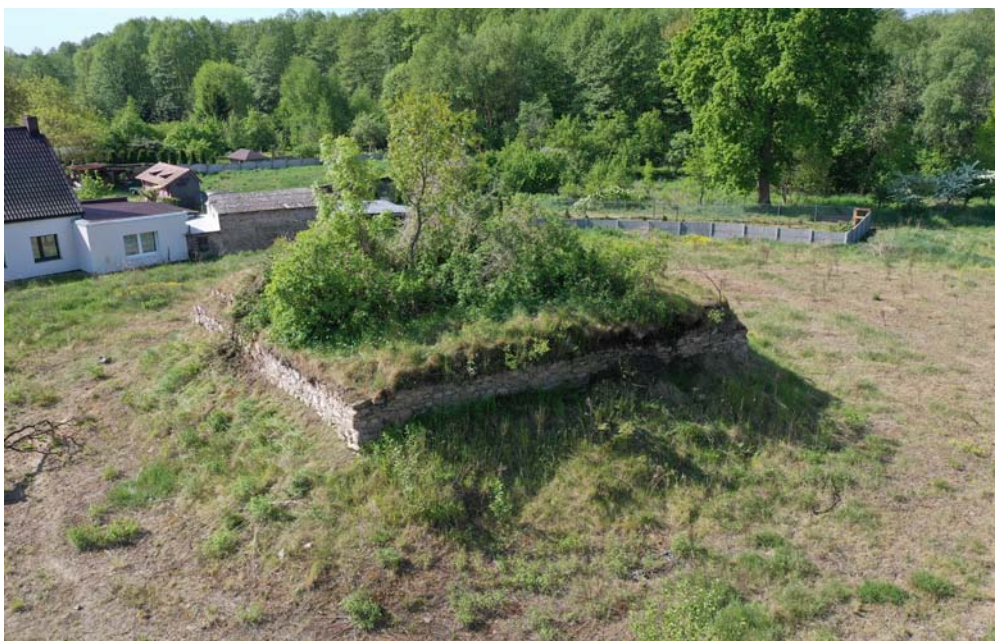
Fig. 8. Relics of the stone tower after the demolition of the site. East view taken in 2022. Photo: H. Augustyniak.

The stone tower was built on a roughly rectangular plan with walls 10.7-11.0×13.1-13.7 m long, with the longer sides facing south and north (Figs. 8 and 9). The perimeter walls of the tower were built from erratic stones laid in layers 0.7 to 0.8 m high, with gaps filled with smaller stones (Fig. 10). The width of the perimeter walls found in the surveys was 2.2 m to the east, 2.3 m to the south and 3.2 m to the west, which indicates that the ground floor room may have measured approximately 6.0×7.0 metres and may have been vaulted. The

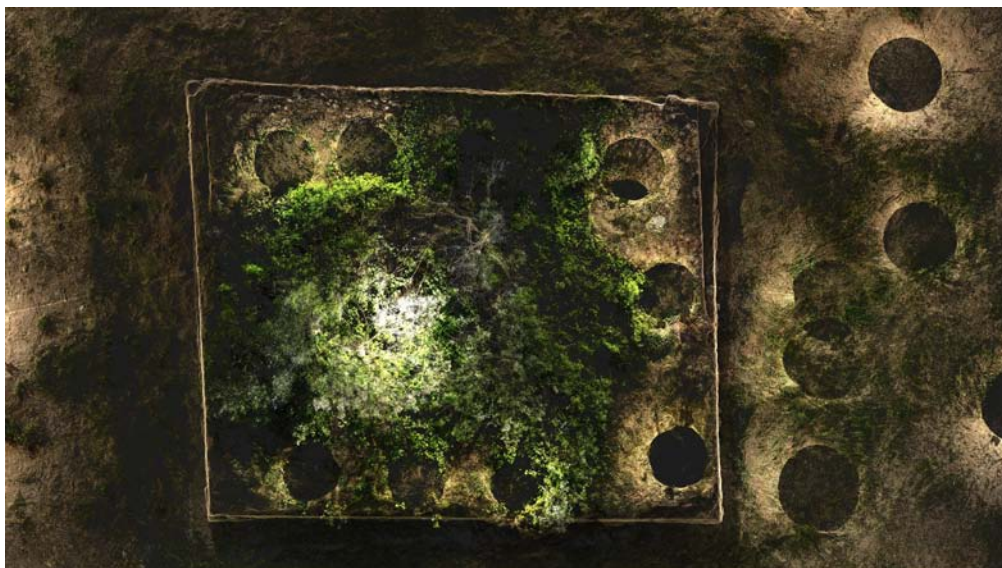
Fig. 9. 3-D scan of the tower. Graphic design: P. Domagalski.

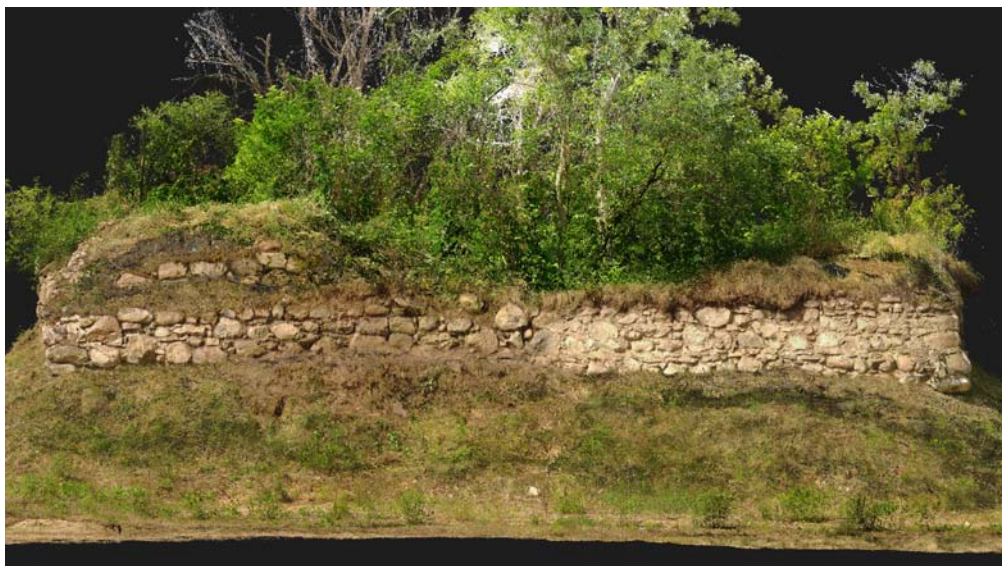
Fig. 10. Scan of the eastern wall of the tower. Graphic design: P. Domagalski.

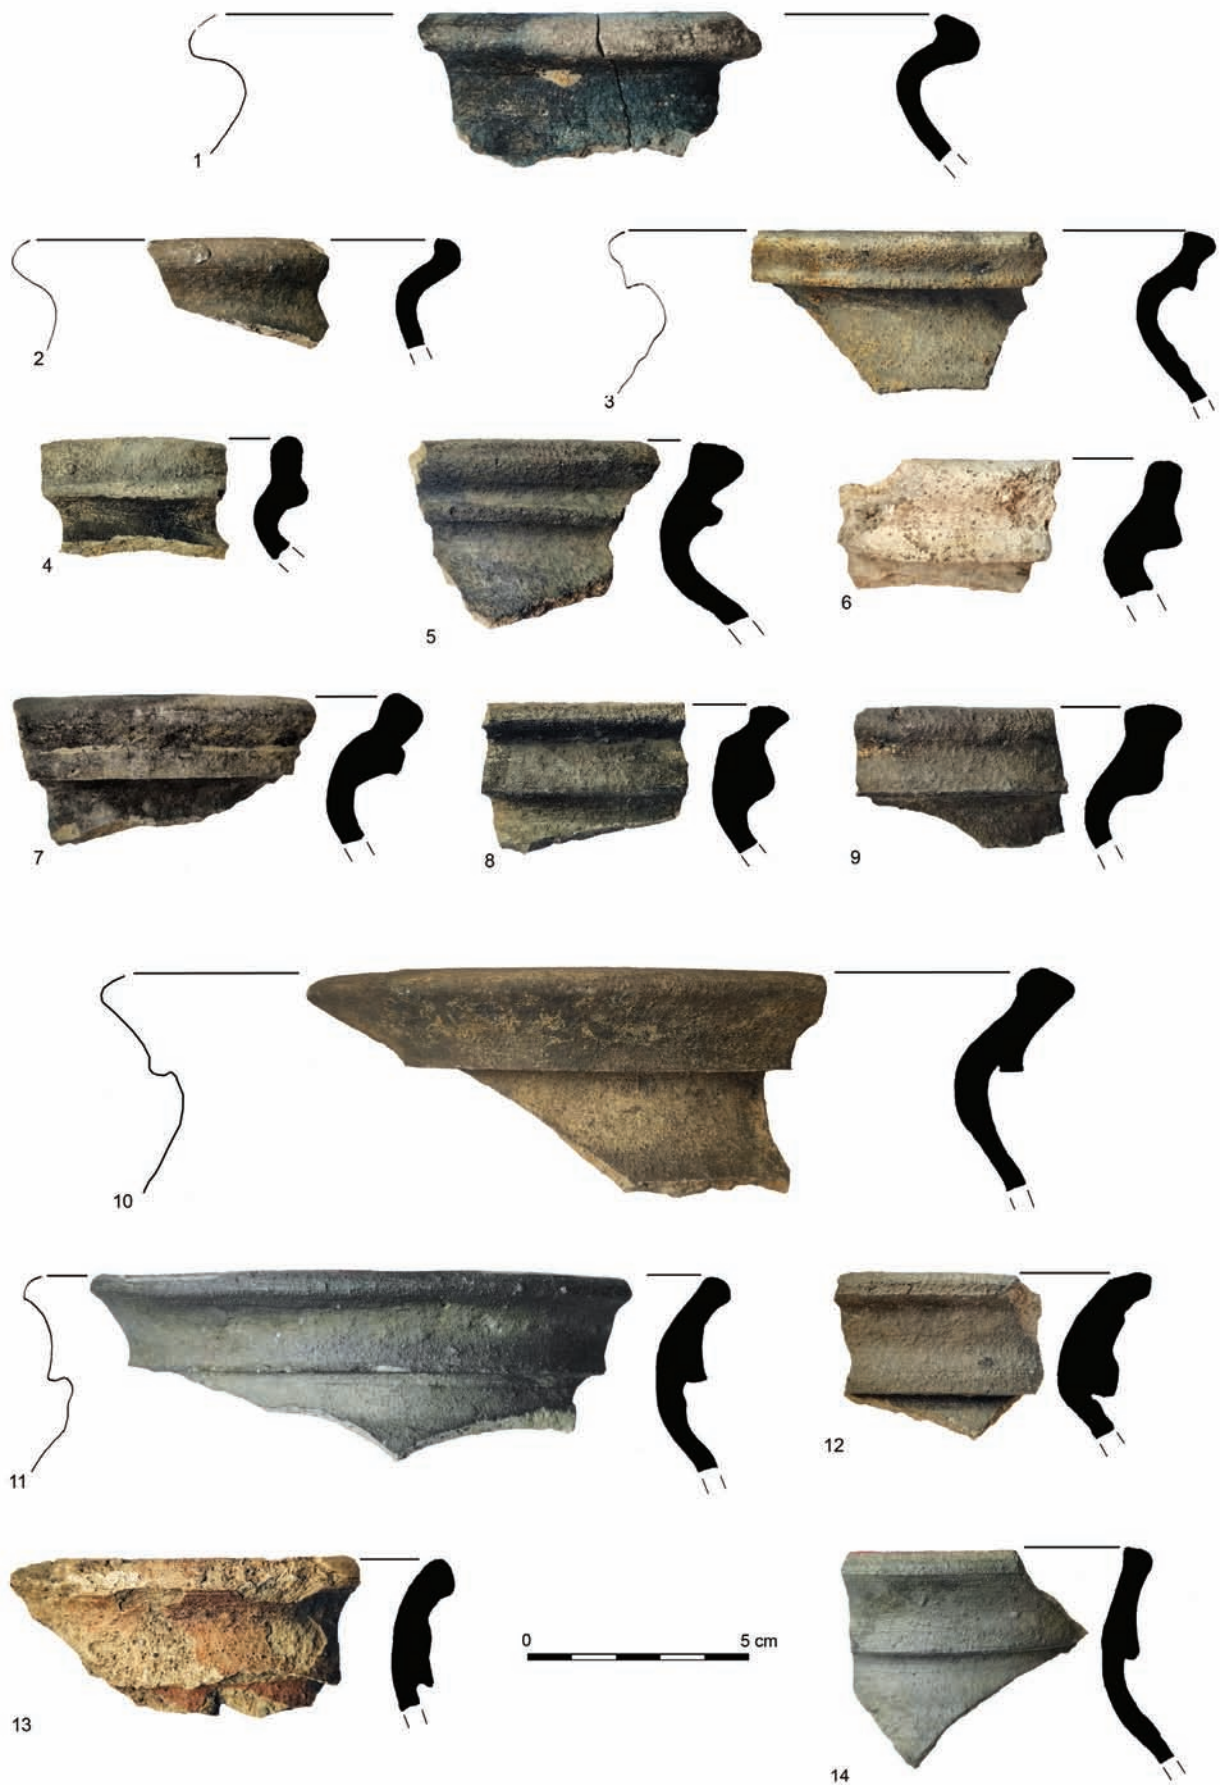
Fig. 12. Pottery. Selection of pot rims. Graphic design: S. Kałagate.

The preparation of food, cooking, consumption, and the associated social and behavioural aspects of eating, drinking, and feasting comprised one of the most important spheres of daily and social life for the inhabitants of the tower castle.²⁷ Among identified kitchenware were fragments of bronze tripod grapens²⁸ and fragments of earthenware pots, referred to as 'grey' or 'steel-grey vessels'. Fired in a reduction atmosphere, they are the most dominant group of vessels unearthed in Lubrza, representing over 97% of the total collection. Less numerous are vessels made of kaolinite or ferruginous clays with a calcium carbonate component and fired in a strongly oxidizing atmosphere to a light yellow, yellow, or cream colour; similarly, much less frequent are products called proto-stoneware (German *Faststeinzeug*). Nine categories of vessels were identified in this collection: pots, jugs, bowls, small bowls, lids, goblets, and miniature dishes (Fig. 12).

These artefacts shed more light on the question of chronology of the tower castle. The discussed ceramic material should be dated quite broadly from the turn of the 13th/14th centuries through the entire

14th century; however, most of the pottery fragments represented here were made during the first half of the 14th century.²⁹
