**Geographia Polonica**

2024, Volume 97, Issue 3, pp. 327-354  
<https://doi.org/10.7163/GPol.0282>

## UNOBVIOUS GEOHERITAGE IN SACRAL BUILDINGS: MILLSTONES IN CHURCHES OF NE POLAND FROM A GEOLOGICAL AND GEOMORPHOLOGICAL PERSPECTIVE

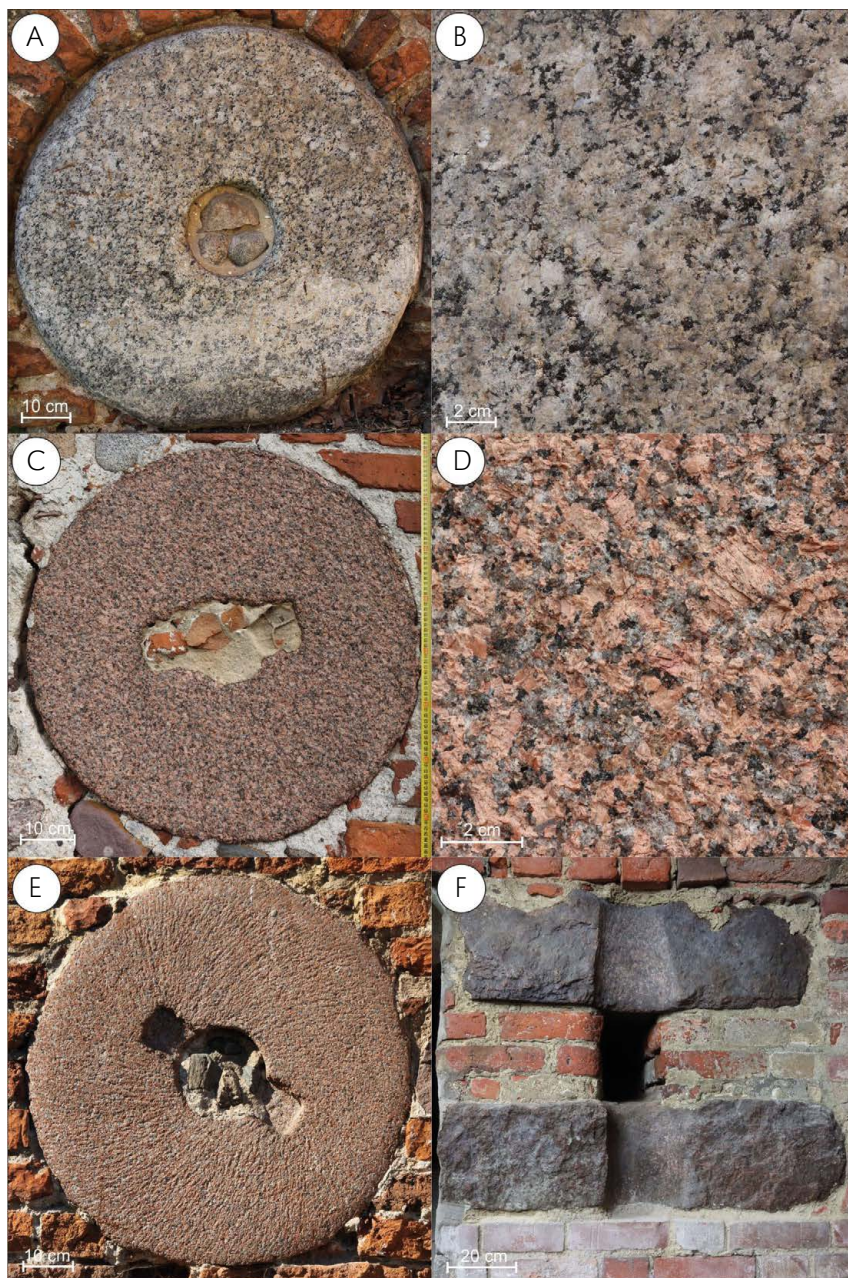
**Figure 3.** Millstones made of Scandinavian granitoids; A, B – stone embedded in the southern wall of the former church in Pułtusk, Revsund granite (erratic), C, D – stone embedded in the southern wall of the church in Gryźliny (Warmia), Finnish or Åland rapakivi granite (erratic), E – stone embedded in the eastern wall of the former church in Pułtusk, Scandinavian granitoid – Småland granite (erratic), F – two halves of a large millstone embedded in the wall of the castle in Olsztyn, coarse crystalline Finnish rapakivi granite (erratic). (Photos by P. Czubla)

The raw material used for the production of millstones was almost exclusively various types of Scandinavian granitoids present throughout Poland as erratic boulders (Fig. 3; Czubla, 2015). Among these, rapakivi granites (both viborgites and pyterlites) were relatively numerous. Revsund, Siljan, Småland, Sala, Uppsala granites, as well as Bornholm granitoids, were also identified. Generally, these rocks exhibit coarse- and medium-crystalline textures and are relatively poor in dark minerals susceptible to weathering, such as biotite.

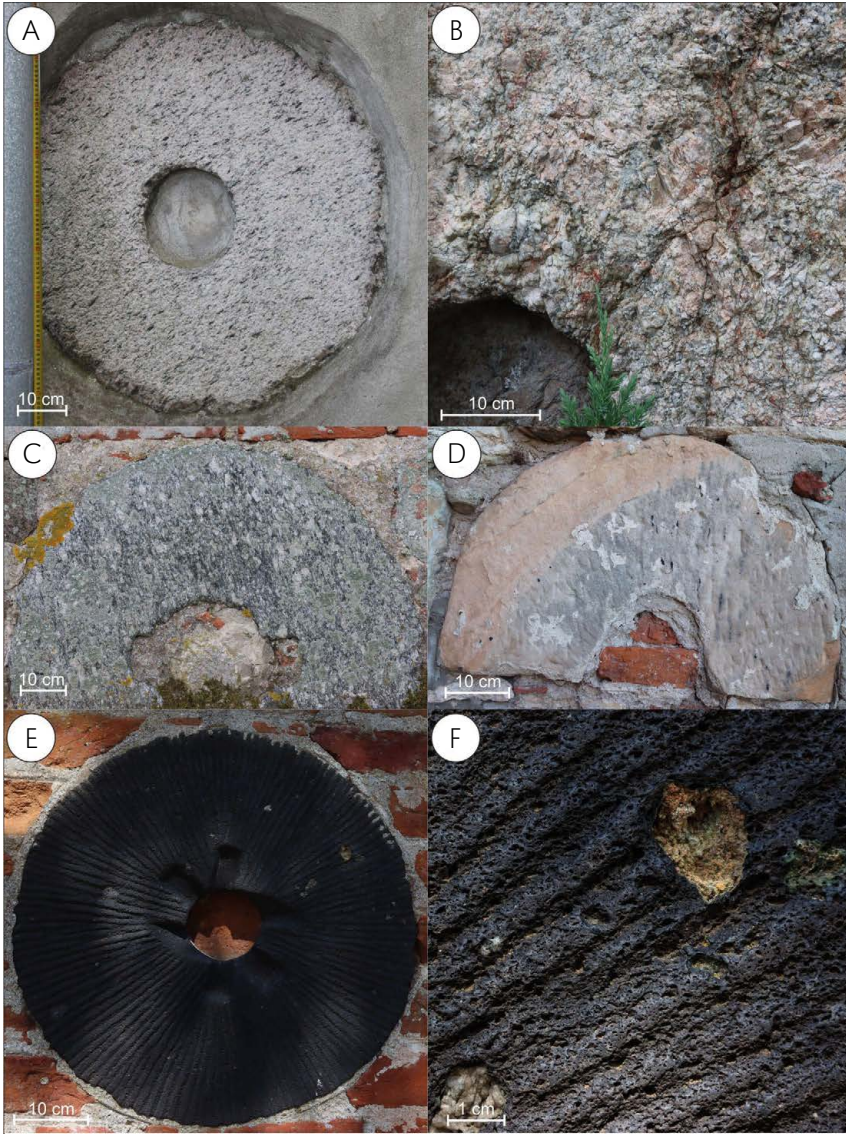
**Figure 4.** Millstones in church walls; A - millstone or semi-finished product in Bodzanów in Mazovia, leucocratic gneiss (erratic), B - semi-finished product at the entrance to the church in Kraskowo (Masuria), coarse crystalline pegmatite (erratic), C - worn millstone or semi-finished product in Rogiedle (Warmia), gneiss with small crystals (erratic), D - semi-finished product used as building material in the monastery church in Sulejów, sandstone from the vicinity of Wąchock (northern Mesozoic margin of the Holy Cross Mountains), E, F - worn millstone in the ruins of the church in Wocław in Żuławy, porous volcanic rock, most likely imported from the Eifel massif (?). (Photos by P. Czubla)

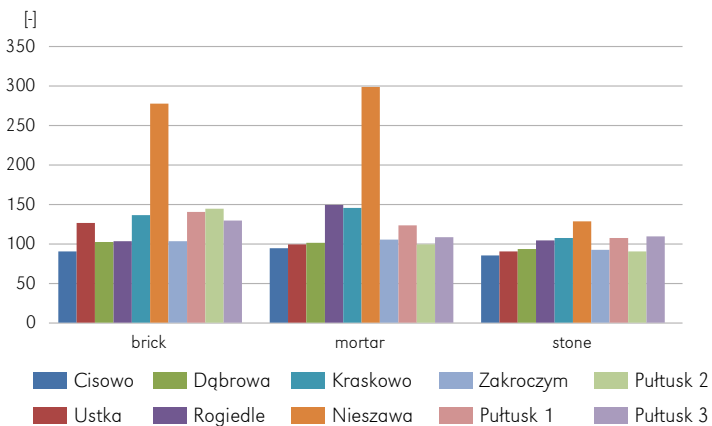
**Figure 6.** Variability of the average index moisture content of building elements forming the walls of churches in the vicinity of millstones

Index moisture values indicate that millstones, as well as other materials used in the construction of church walls, not only exhibit lower moisture levels, on average by around 30 units, but also less variability in moisture compared to the moisture content of bricks and mortar (Fig. 6).
