REMAINS OF THE NEGLECTED PAST. OTTOMAN FORTS ON PLANINICA HILL, MONTENEGRO

Bugaj U., Lutovac P., Trzeciecki M., Bogacki M., Chwiej M., Novak M. and Polak Z. 2014. Remains of the Neglected Past. Ottoman Forts on Planinica Hill, Montenegro. *Sprawozdania Archeologiczne* 66, 385–398.

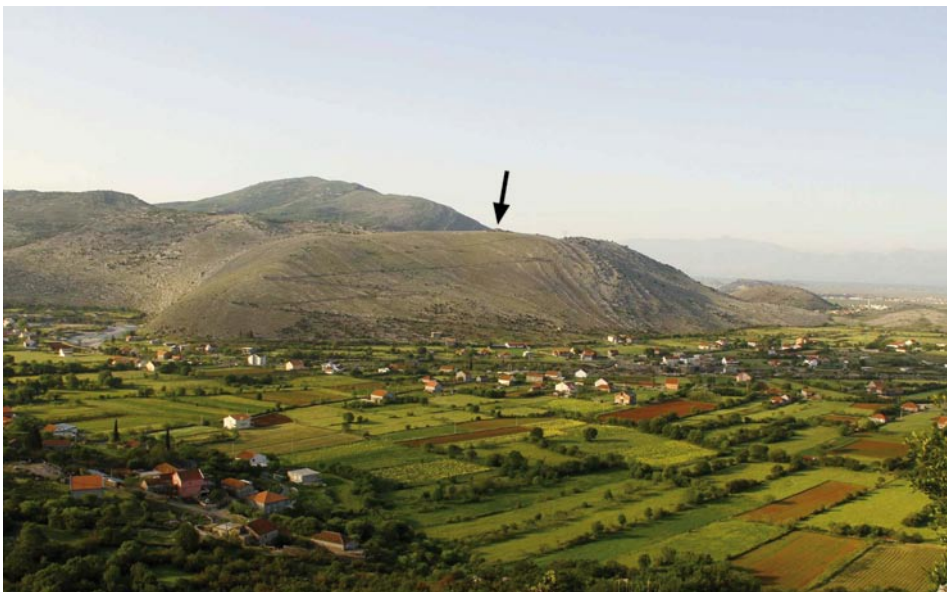
Fig. 2. Planinica hill — view from the North-West. In the foreground — Dinoša village, next — the Zeta plain and outlet of the Cijevna valley. Location of the object I marked by arrow. Photo M. Trzeciecki

Planinica’s hillsides are rather gently shaped with the highest exposure to the north. The slope descends mildly to the west ending with a small number of isolated hillocks along the Cijevna river (Fig. 2). Minor karst sinkholes surround the hill from the south-east. The summit forms a long, even ridge along a northeast-southwest axis, with a culmination in the central part. The entire hill is almost completely devoid of vegetation.

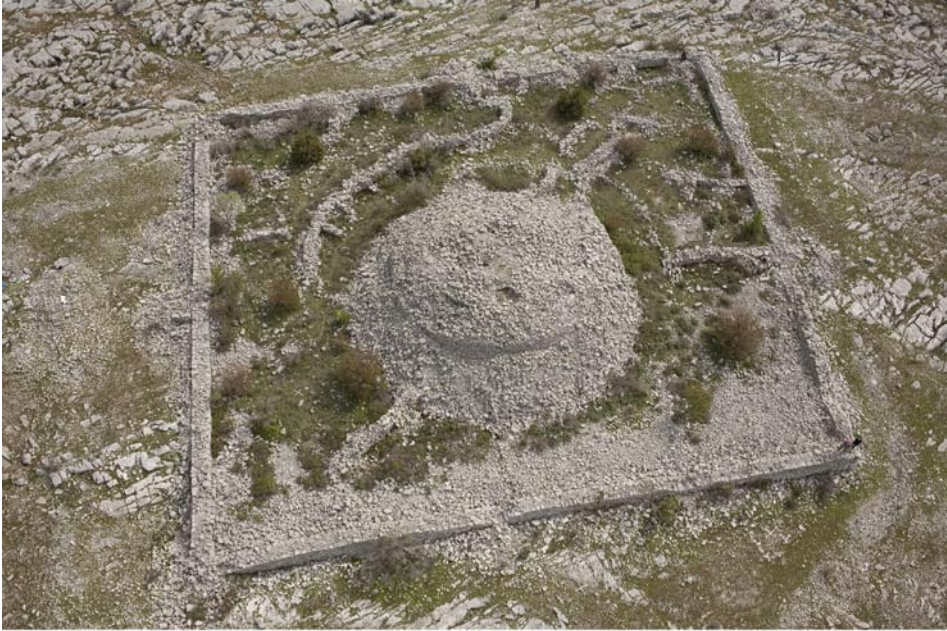
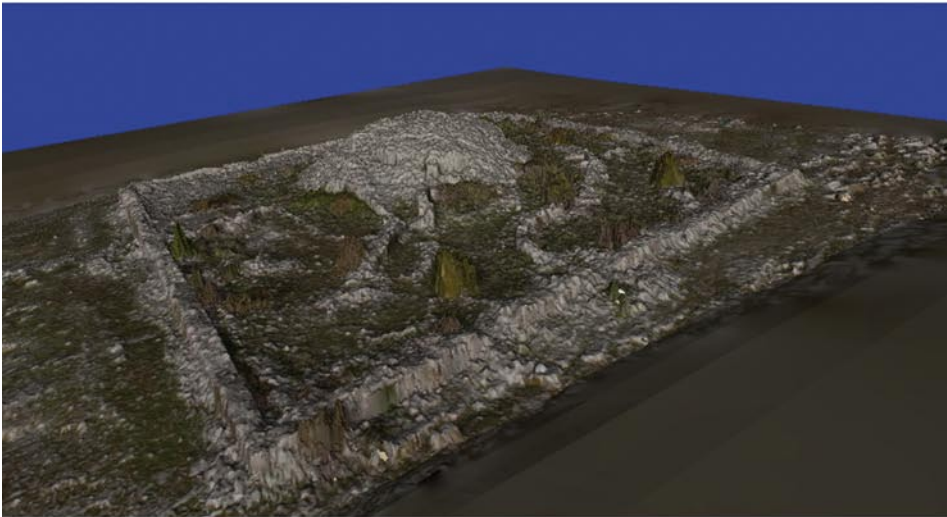
Fig. 4. Object I — bird's eye view (1), digital elevation model (2). By M. Bogacki

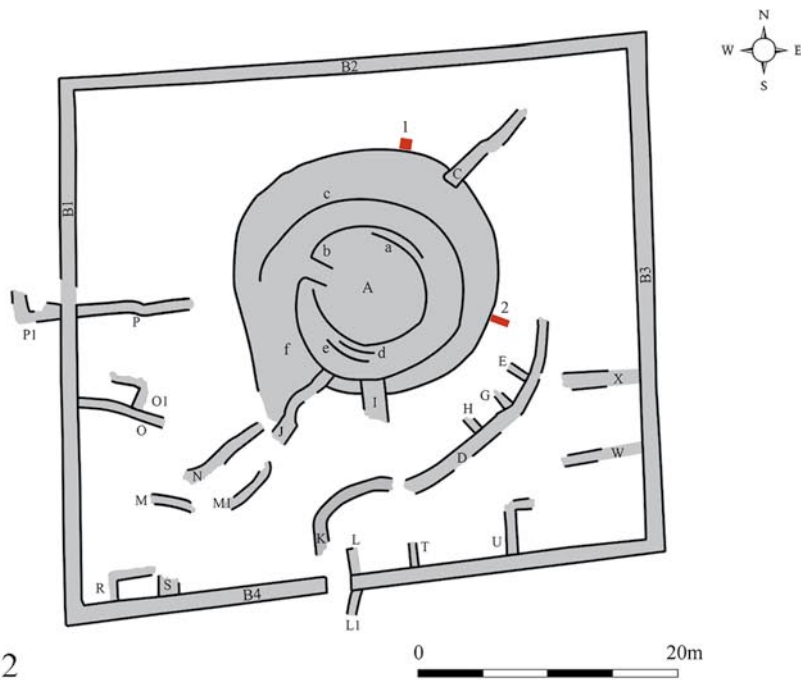
Fig. 5. Object I — digital surface model (1), plan of the wall relics. Sondage trenches marked by red (2).
By Z. Polak, M. Trzeciecki)

At the base of the tower two narrow test-trenches (sondages) were excavated (Fig. 5: 2; 7). From the north-east stone rubble was removed and the well preserved outer façade of the wall was uncovered. It lies directly above the bedrock, 20–40 cm below the present ground level. No layers related to the functioning of the building had been preserved there (Fig. 7: 1). From the east, the foundation level of the building was uncovered and the sequence of layers related to the functioning and destruction of the building was recorded (Fig. 7: 2). The outer wall was founded approximately 60–80 cm below the present ground level, on the bedrock which was covered with a 20 cm deep layer of brown-grey dense, loamy humus related to the functioning of the building. Small and medium-sized rubble lying over it was thoroughly mixed with brown humus. It is probably related to a slow/gradual destruction of the tower. Higher up there was a layer of thick rubble and hewn stones from the façade of the walls (Fig. 7: 3). The destruction in this part of the tower proceeded faster and must have taken place quite recently.

Inside the enclosure there are relics of stone structures representing the subsequent phases of the functioning of object I (Fig. 5, 8). They are constructed much less carefully than both the tower and the enclosure. In their construction hewn or broken stones of different size were used. They were placed in a chaotic manner, usually with their longer sides inwards. These were rather provisional constructions that seem to have functioned relatively briefly.

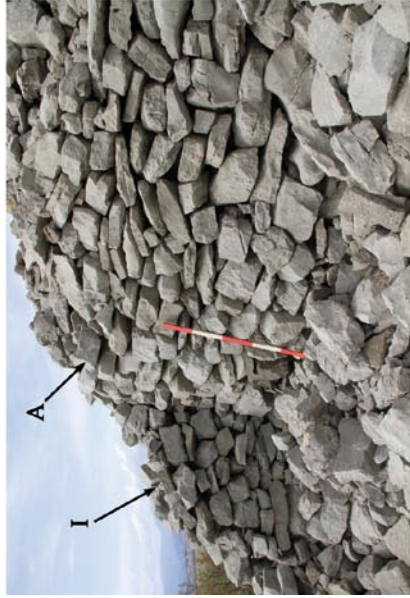
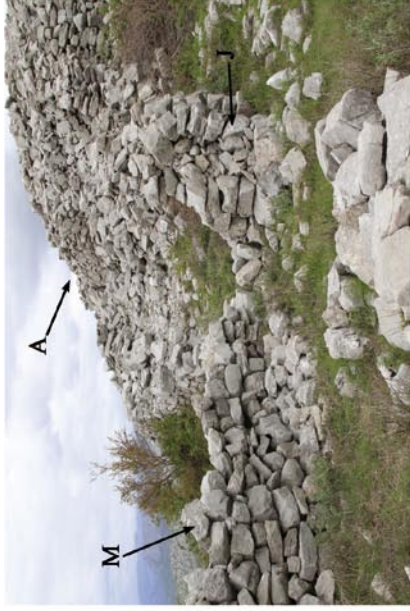
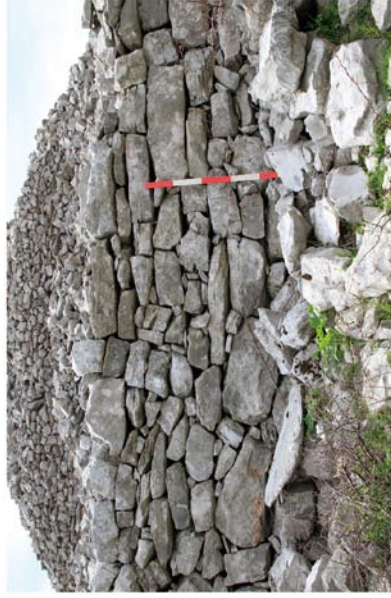
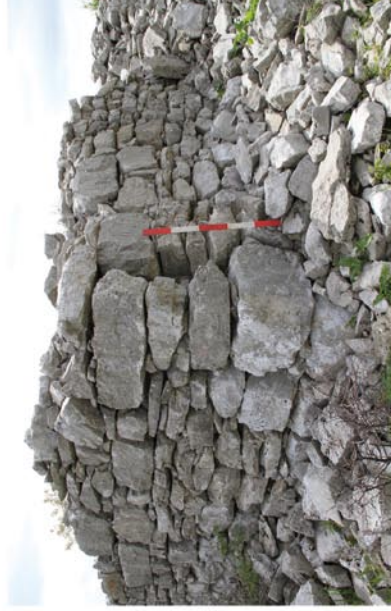
Fig. 6. Object I, structure A — southern façade with later added wall I (1), ramp leading to the top of the structure with later added walls J and M (2), western façade of the enclosure wall B (3), NW corner of the enclosure wall B (4). Photo M. Trzeciecki

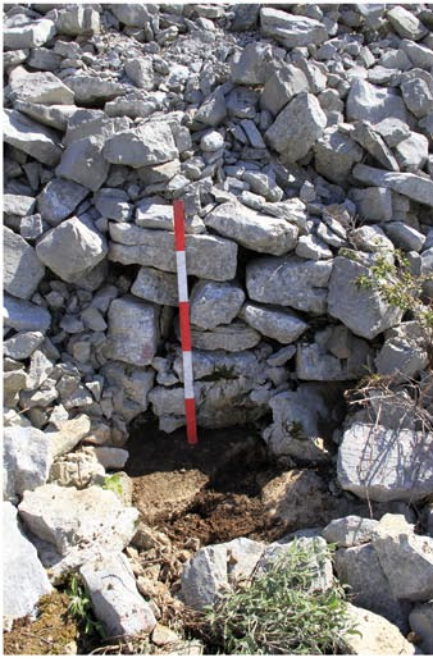
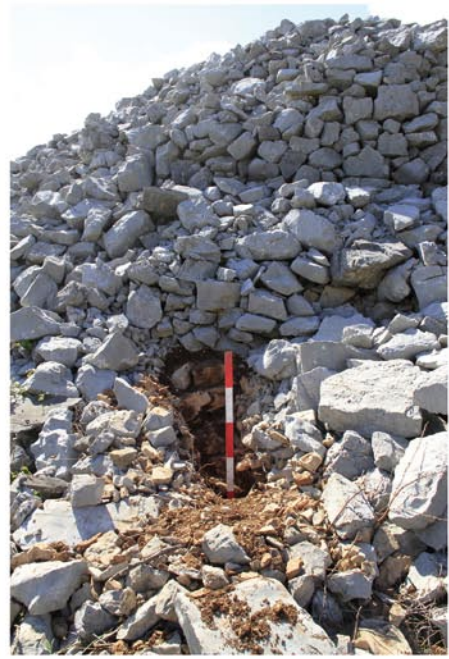
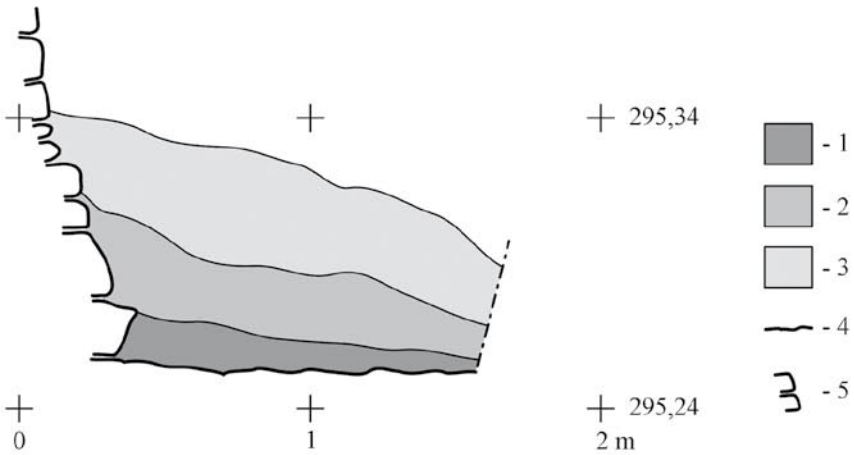
Fig. 7. Object I, structure A. Sondage trench 1 — view from the South-West (1), sondage trench 2 — view from the South-East (2), North-Eastern profile of the trench (3): 1 — brown-grey humus, 2 — small and medium-sized rubble; 3 — thick rubble and hewn stones 4 — bedrock, 5 — façade of the wall.

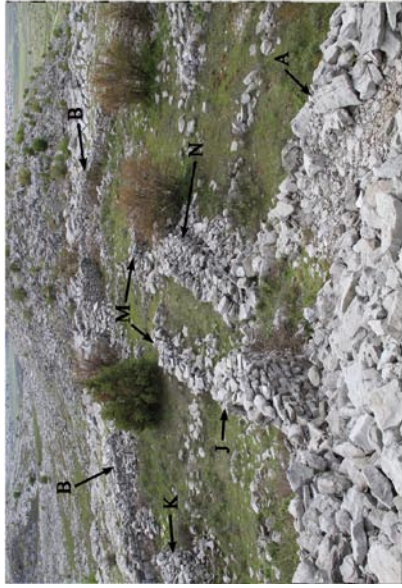
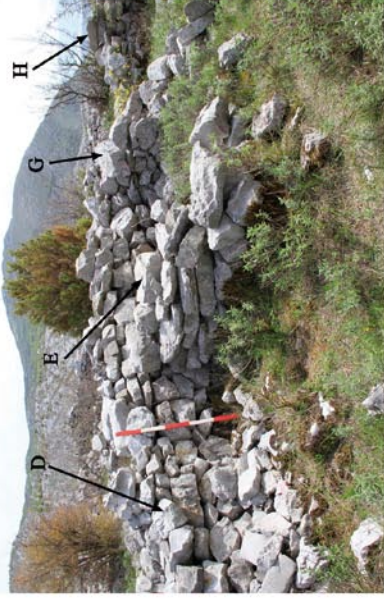
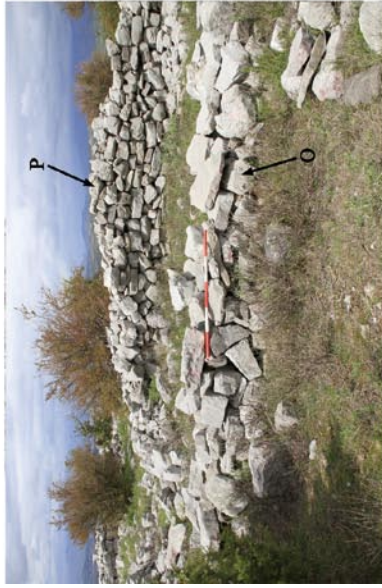
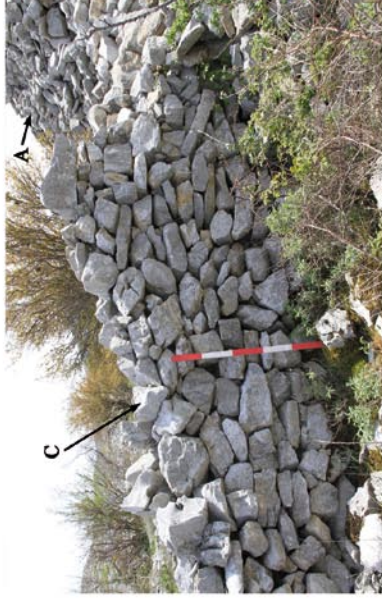
Fig. 8. Object 1 — SW part with walls B, J, K, M and N (1), relics of stone walls inside the enclosure: walls D, E, G, H (2), walls O, P (3), wall C (4).
Photo M. Trzeciecki

The wall surrounding the tower from the south east (D) and the short walls perpendicular to it (E, G, H; Fig. 8: 2) are related to the initial period of the functioning of the tower. The remains of undefined constructions (O, P; Fig. 8: 3) adjacent to the “new” entrance within the western part of wall B, as well as the wall closing the ramp (J) together with some other badly preserved relics (M, N), most probably refer to a change in the disposition of space within the enclosure (Fig. 7: 2; 8: 1). Connected with this reorganization are probably also the wall sectors added to the tower from the south (I, Fig. 6: 1) and north east (C, Fig. 8: 4), as well as the remains of the wall (K, L) adjacent to the “older” entrance, completely covered with stones. The walls added perpendicularly to the inner façade of the southern and eastern parts of the peripheral wall (R–X) may have belonged to buildings existing during the functioning of the entire structure.

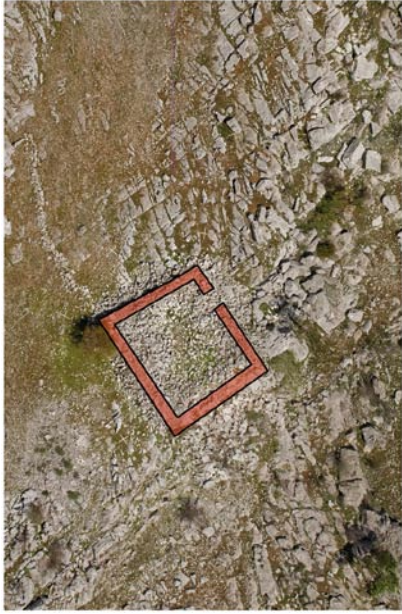
Fig. 9. Object II — orthophotographic map (1), object III — orthophotographic map (2), road No 1 — bird's eye view (3), road No 3 near object I — bird's eye view (4). Photo M. Bogacki

At the western edge of the top of Planinica, 52 m west of object I, a rectangular wall denoted as object II (Fig. 9: 1) was registered. It has a trapezoid plan (11.90 and 10.70 m), the walls are preserved to a height of 1 m. Its longest side is situated along the north-west axis. The object is structurally homogeneous, the façades are constructed with stones of different size with no mortar to bind them, showing no tendency for a regular pattern. The inner part is filled with small rough-hewn stones. The south western wall is the most badly damaged, parallel to a natural bedding fault. Clearly visible is only the outer line of the wall, hence the wall thickness there has not been defined. The other walls are better preserved, their thickness varies from 1 to 1.25 m. In the south eastern wall there is an entrance 1 m wide, situated closer to the north eastern wall and not on the axis.

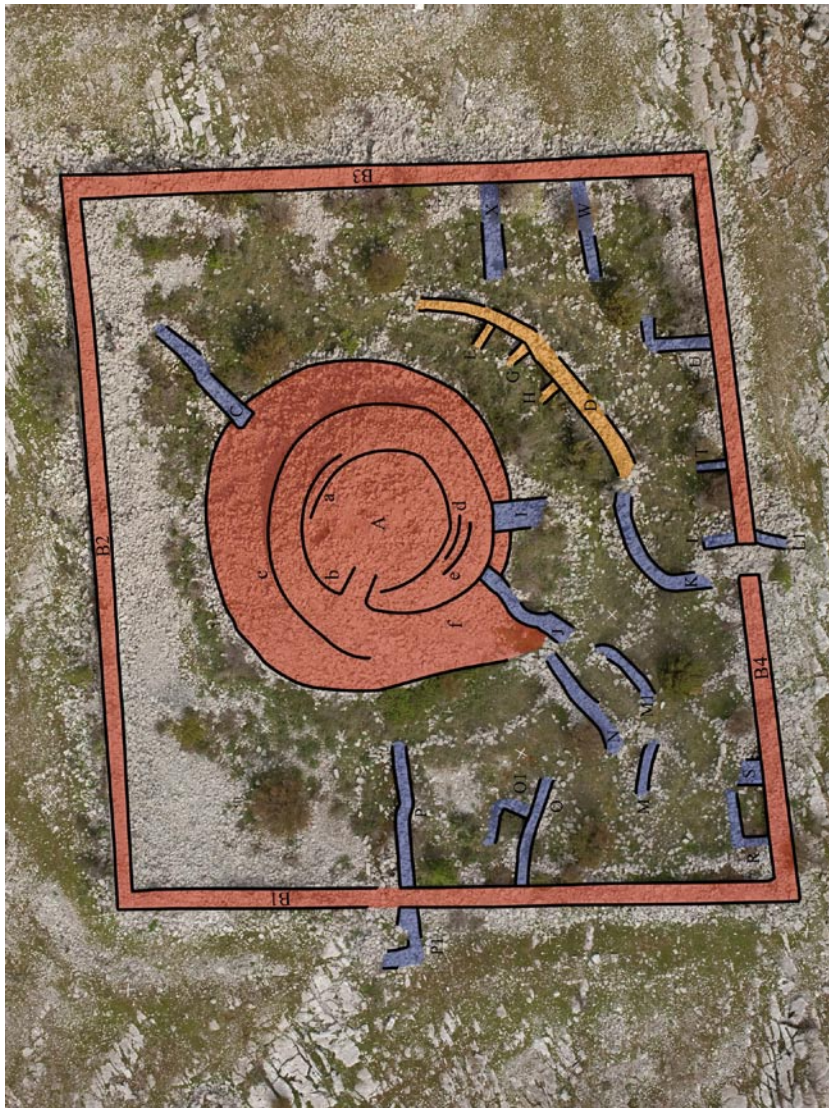
Fig. 10. Object I — orthophotographic map with the stratification of wall relics (by M. Bogacki, Z. Polak and M. Trzeciecki)

The analysis of the interrelations of the walls of object I allows us to distinguish at least two phases of its exploitation (Fig. 10). First the round tower was erected together with the ramp leading to its top and the rectangular enclosure wall with an entrance in the southern curtain. Probably already then the structures within the enclosure were in existence — its remains are the arched wall D. The second phase is related to a new entrance in the western curtain and to the blocking of access to the ramp. The wall unit next to both entrances should also be regarded in the context of changes in communication system inside the enclosure. Road No 1 is functionally related to object I (connecting it with object V), as well as roads No 3 and No 4 heading to the foot of the hill. It seems that the roads No 1 and No 2 are the oldest — road No 1 is related to the older entrance into object I, while road No 2 in its final section had been destroyed by the construction of road No 4. Roads No 3 and No 4 represent one functional unit within the younger “horizon”. The youngest is the only partly completed road No 5, sections of road No 3 and No 4 had been destroyed by its construction.

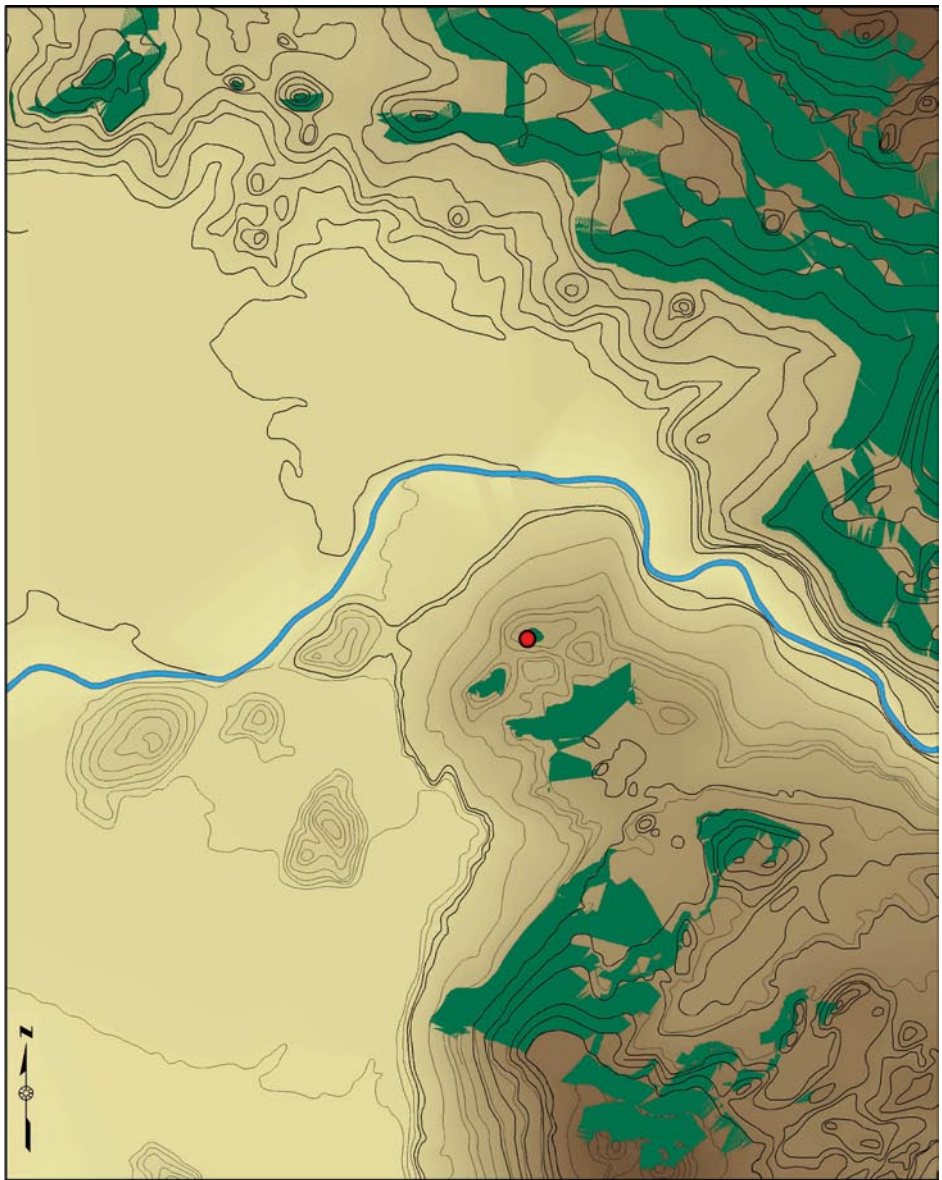
Fig. 11. Observatory tower on Planinica hill — visibility analysis. By M. Chwiej

In order to evaluate Planinica as a strategic point a view shed analysis has been performed (Fig. 11–12). As one of the GIS tools it is being adopted by archaeologist to enhance seemingly invisible features of visual landscape. In order to perform such a task a digital elevation model (DEM) reflecting terrain is needed as well as a point feature representing location of observers. This study is focused only on one aspect of data derived from the Malesija region to assess the visibility from given viewpoints. The first step was to create a DEM of the area derived from digitized contours of the topographic map using ESRI software package. DEM, like any other raster, is a matrix of cells where each of them is assigned with a value approximating the elevation of area in that particular spot. Then a couple of arbitrary points are being chosen to produce a set of line-of-sight analyses that make up a new raster based on heights calculated on a model. Each cell in that raster has a unique value which is corresponding to appropriate viewpoint in the input feature class. For example, cells that cannot be seen from a given location are described with value of 0. Cells that can be seen are described with 1. As a result a series of simple raster based maps for each viewpoint is created. The differences between them are significant. Next step should be the creation of cumulative view shed analysis based on known site locations.

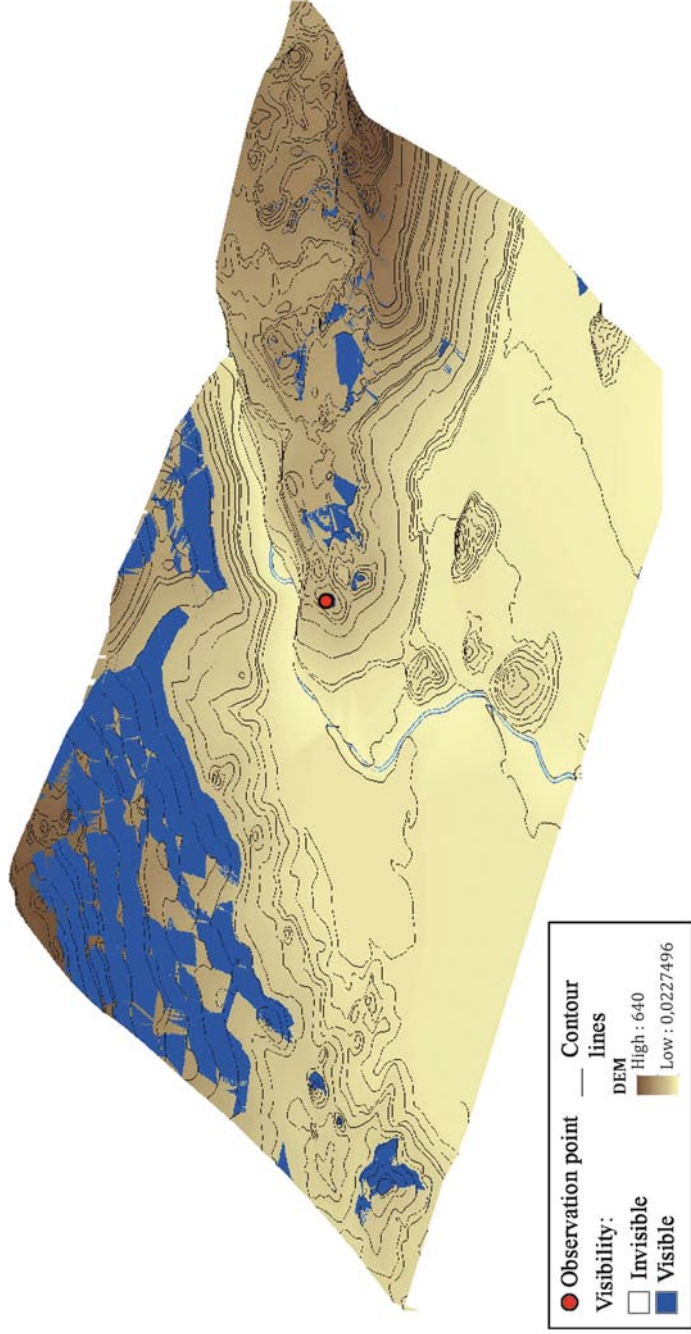
Fig. 12. Observatory tower on Planinica hill — visibility analysis imposed on digital elevation model. By M. Chwiej

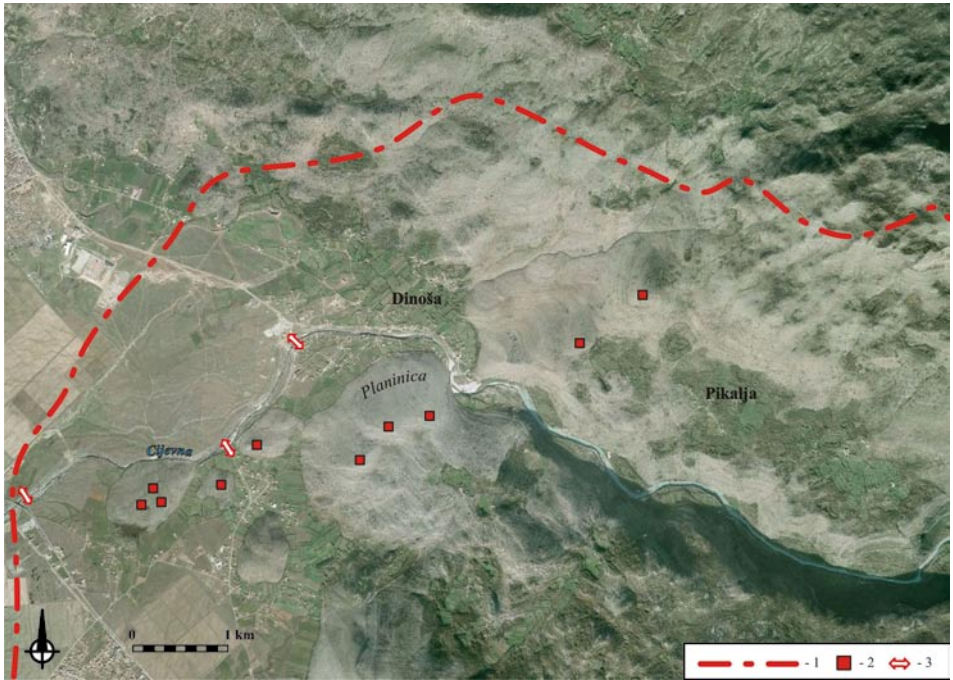
Fig. 13. Ottoman border control system in the area of Planinica hill. 1 — border line in the years 1878–1913, 2 — forts, 3 — bridges on Cijevna river. By M. Trzeciecki

border control system (Fig. 13). It seems very likely that there was something more to this idea than just a temporary military purpose. Forts and roads building can be regarded as the element of modernization of one of the most deprived regions of the Ottoman Empire, of the changes forced by political events. In those days the region of Gruda suddenly became an area of confrontation, as the Ottoman Empire parted the political arena and “young Balkan nations” descending into it, searching for their ways to independence (Blumi 2003, 237–?).
